No.	DATE	REVISION
McNEELY ENGINEERING & STRUCTURES LTD.		
CONDITION SURVEY		
OWNER MINISTRY OF TRANSPORTATION OF ONTARIO		
BDIMS COUNTY: <u>2</u> TOWNSHIP: <u>22</u> HIGHWAY 31 OVERPASS (31-204) SITE: <u>22</u> A UNDERSIDE OF DECK DETERIORATION SF# <u>UK</u> DRAWING TYPE SCAN:		
DATE NOVEMBER 1989		
DRAWN J.J.S.	PROJECT No. 89-1117	DRAWING No. 3
CHECK A.E.

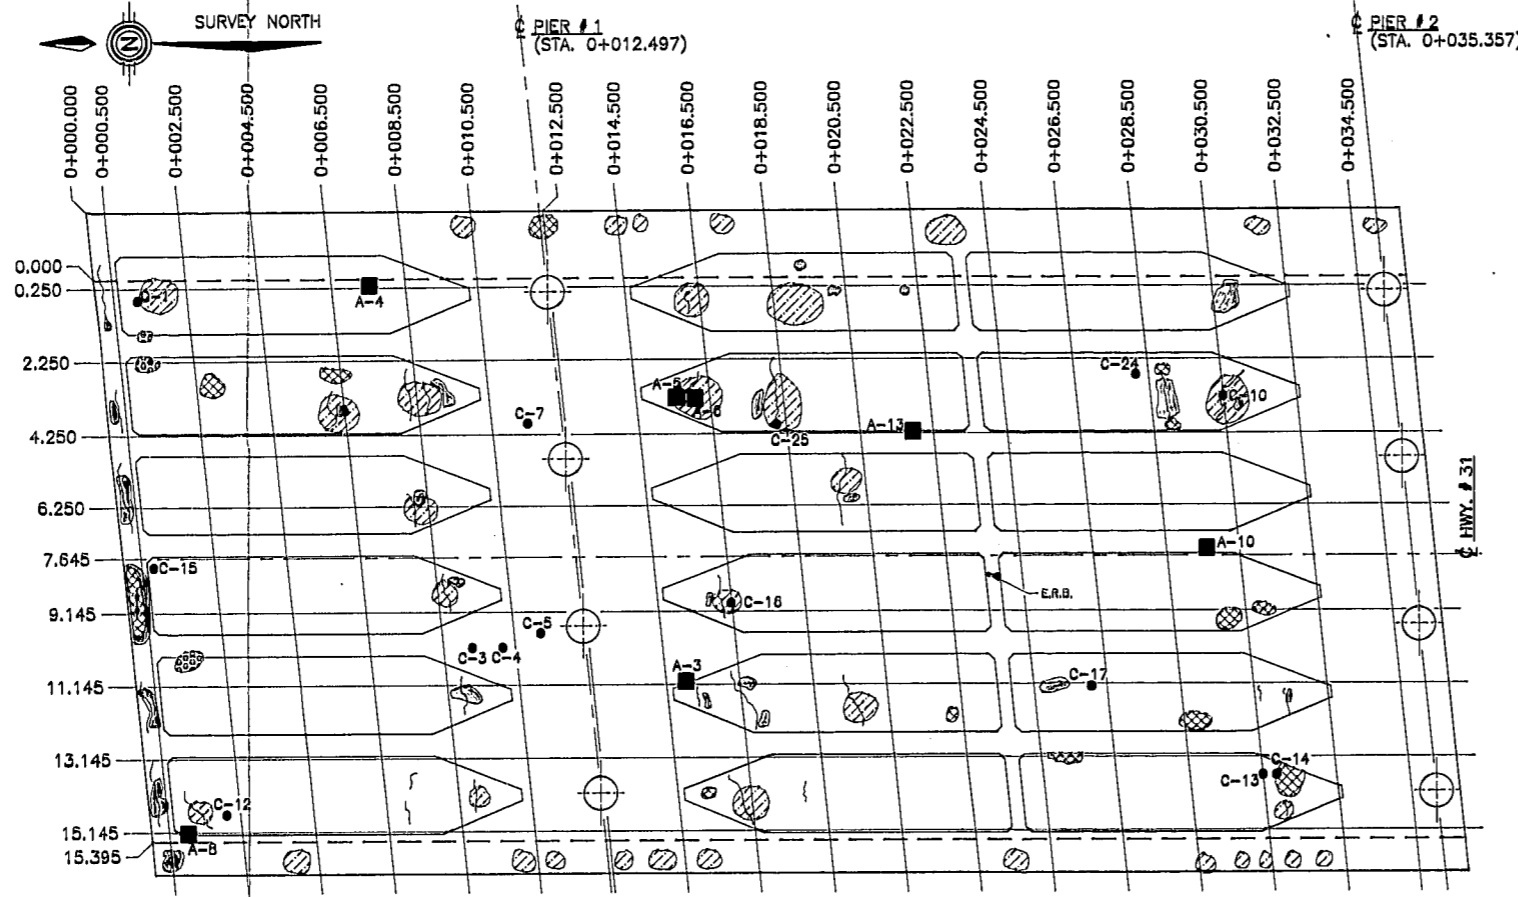
HALF PLAN

NOTE: ALL CRACKS IN UNDERSIDE OF DECK ARE MEDIUM CRACKS AND ARE DAMP STAINED.
